Urban Walls: Examination and Possible Restoration. Two Case Studies

Valeria Montanari

Keywords: urban walls; ancient town; landscape; territory; conservation; restoration

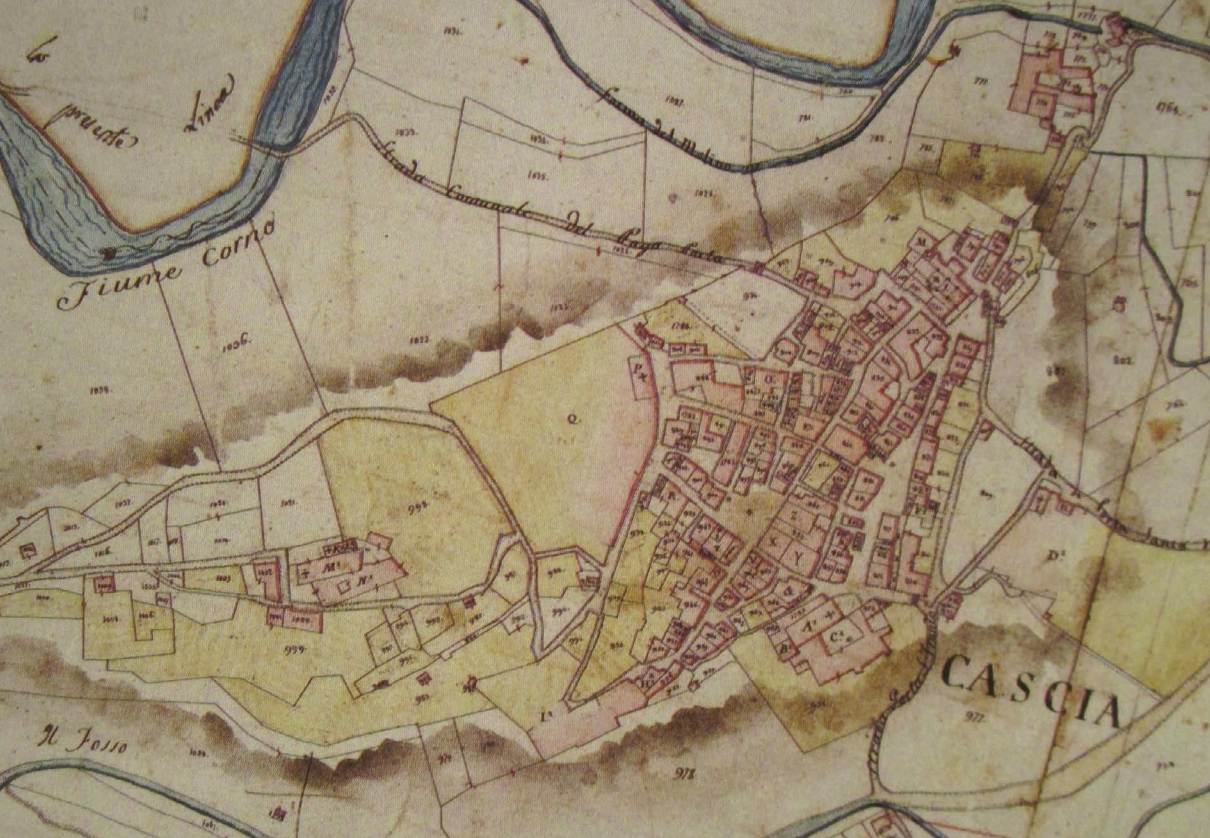
Fig. 01: Plan of Cascia, early 19th century.
Fig. 02: View of Cascia, early 20th century.

In fact, a series of different projects were undertaken over a number of centuries, demonstrating the exceptional attention paid by the town of Cascia to the preservation of its perimeter wall, a concern confirmed, for that matter, by a decree issued in 1587 to ensure that “the walls erected to defend the town must be in good condition and maintained constantly”.¹² The same precautions were renewed in 1642, when, fearful of being drawn into the clashes that raged throughout Italy in those years, the town council ordered that the boundaries and the defensive structures of the town be ‘reviewed’. Despite the care taken, the seismic quakes that continually struck the area inflicted immense damage on the structures, as in the case of the earthquake of 1599, which destroyed the entire portion of the wall between the ‘Rocca’ fortress and the Santa Margherita gate. On each occasion, attempts were made to replace what had been lost, as shown by the plaque placed above the Eastern gate, commemorating the restoration carried out under Pope Clement X in the year following the 1703 earthquake. This same period is identified as that of work done to lower the height of the tower found in the proximity of the San Francesco gate, in order to ensure its stability, which had been compromised by an earthquake some years earlier. (Fig. 01)

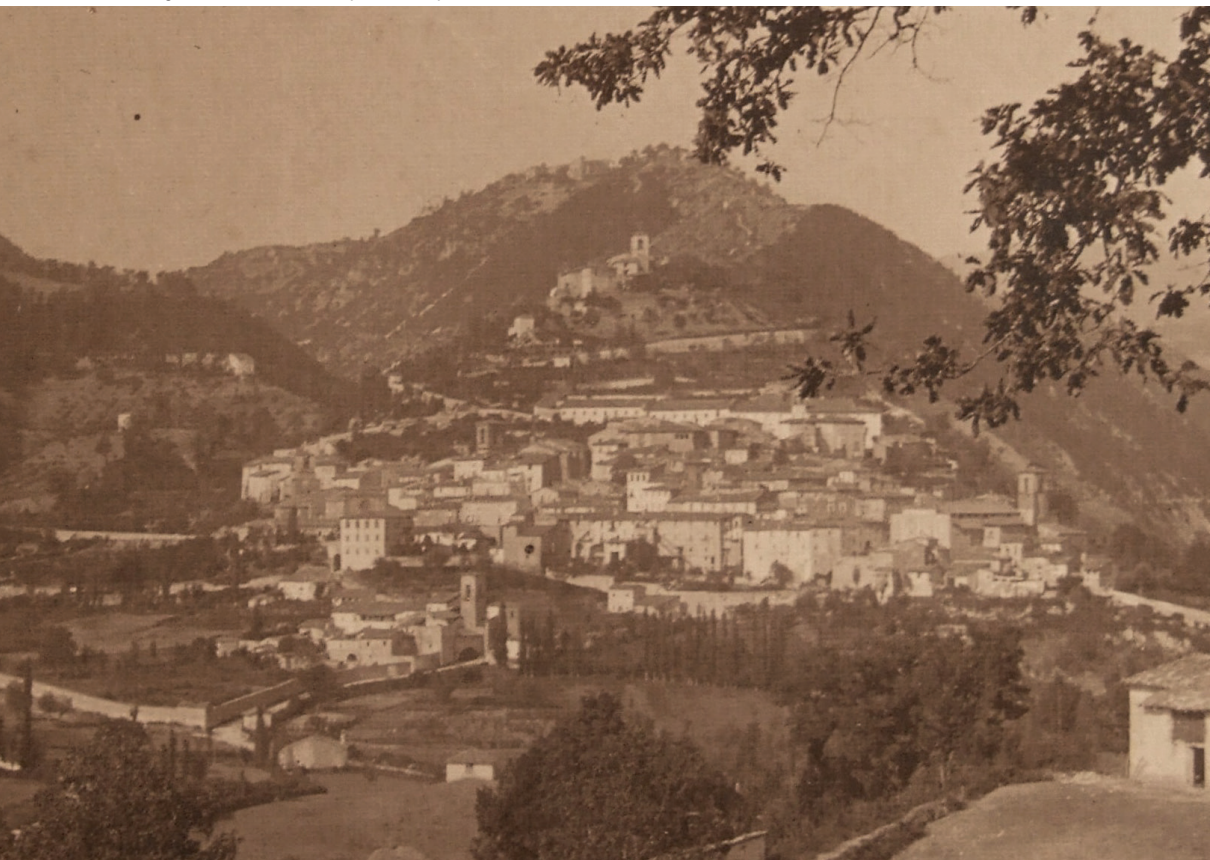
At present, only very limited portions of the original fifteenth-century fortifications are still visible. Much was either lost for good on account of the seismic events of the last two centuries or reused as part of the architecture of subsequent residential constructions. (Fig. 02) Of the seven gates of the town wall, only the Eastern gate and the Leonine gate are visible today, along with the 'Rutiloni gate' (opened in the perimeter wall of the Pauline 'Rocca' in 1571, on the initiative of the town's governor).¹³

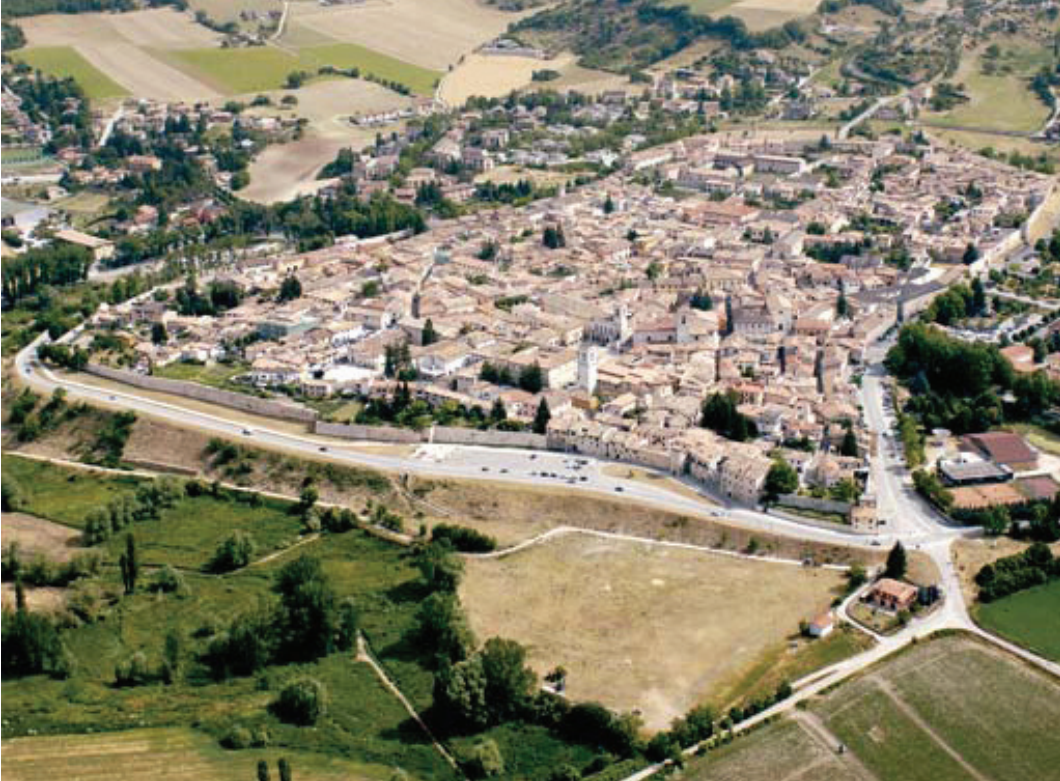
Fig. 03: Norcia, view of the town before the recent earthquake.

Norcia is entirely girded by a wall interrupted by 8 gates. The town fortification walls are interrupted by towers with a quadrangular plan, with parallel vertical walls; of the more than 20 original towers 17 have remained, some of them being incorporated into buildings constructed in later eras.²⁶ Inside the walls, the urban structure has a rather regular grid in the eastern part, which is marked by parallel axes, while to the southwest it is articulated around Piazza di San Benedetto, a quadrangular space surrounded by the most important buildings.²⁷ (Fig. 03)

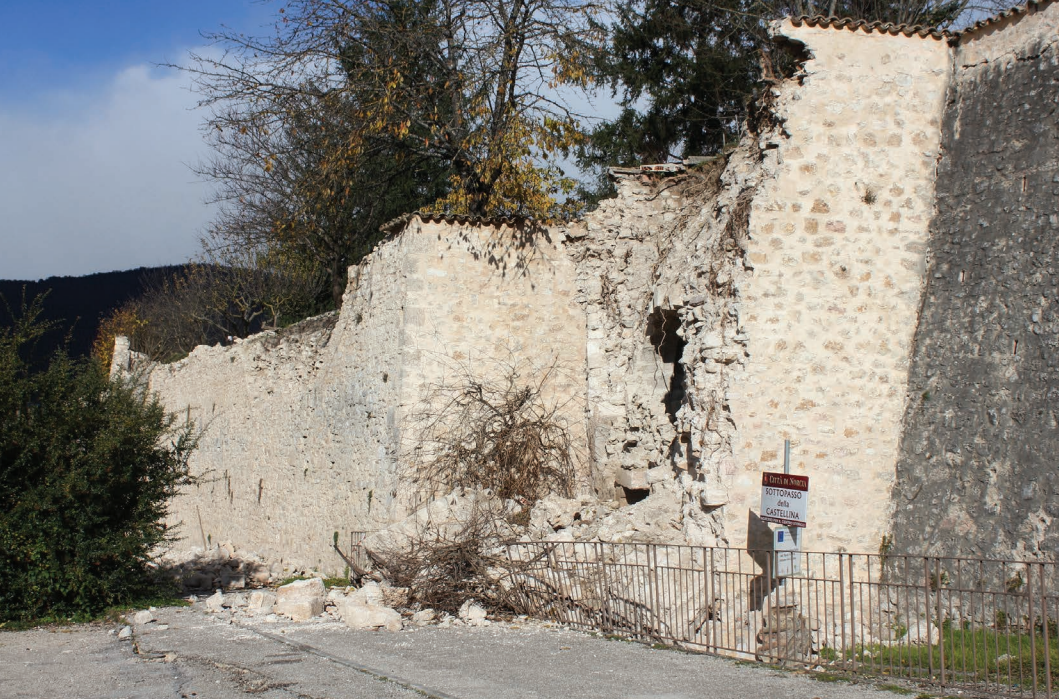
Fig. 04: Norcia, the wall near 'Porta delle Ceresce', after the recent earthquake.

On the western side of the wall is Porta delle Ceresce (or Molar), built in the fourteenth century and then reclosed in 1560 (Fig. 04), when an underground passage was opened to link the wall with the “La Castellina.” To the northwest is Porta di Santa Lucia, named after a nearby convent of the Poor Clares during the eighteenth century; the gate has undergone a number of renovations, and it owes its current appearance to nineteenth-century interventions. The road leading from Porta di Santa Lucia to Piazza di San Benedetto joins a road section onto which look a number of religious buildings, their long sides parallel with the road: the Misericordia church, the San Francesco church with its convent, Piazza di San Benedetto and the San Lorenzo church. On this route, the urban structure of the town's lower part appears to be articulated; recent studies attribute it to a later phase as to the construction of the first town nucleus.³²

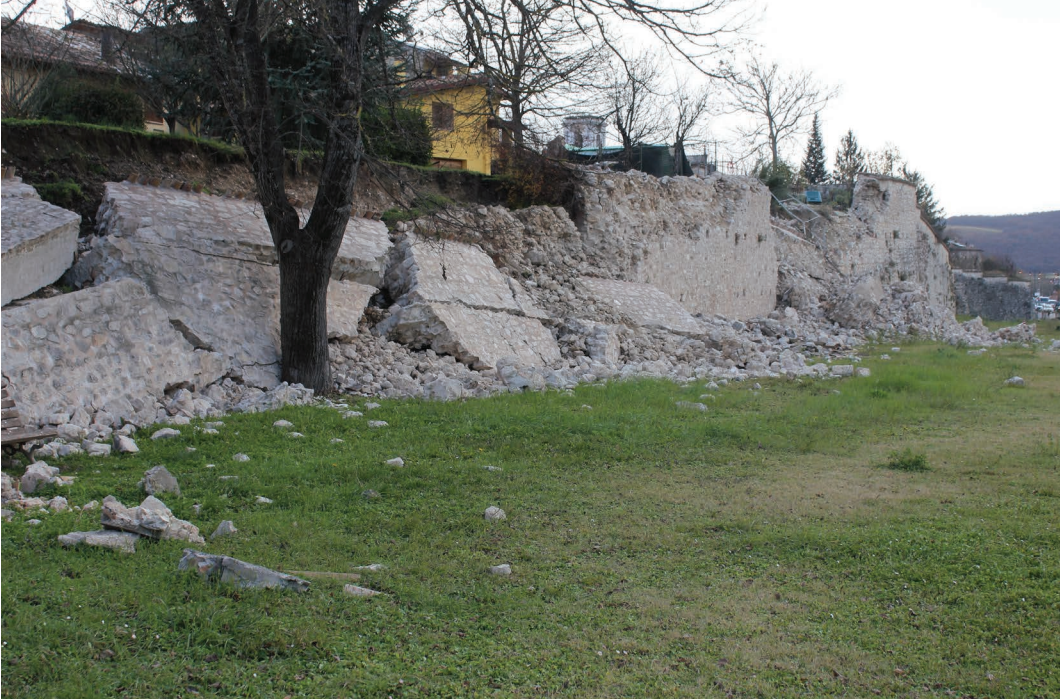
Fig. 05: Norcia, western section of the town walls after the recent earthquake.

The western section of the town walls, which winds from the polygonal bastion of Santa Lucia to the “Sportella” (that is, the postern at the southern tip of the circuit), is the part that over time underwent the greatest number of renovation and adaptation works.³³ Before the construction of the ring road girding the wall, built on an artificial embankment, the terrain on this side sloped down naturally towards the mills placed on the canals, the fields constantly watered by a system of water meadows. This special cultivation technique, by which fields are irrigated during the winter as well in such a way as to keep the farmed land from freezing, was introduced into the Santa Scolastica plain between the fifth and sixth centuries by the Benedictine monks. It is therefore possible that the different consistency of the soil from the eastern area of the town led to a higher vulnerability to seismic agents (Fig. 05), with the consequent need for periodic renovations of portions of wall; however, a part of

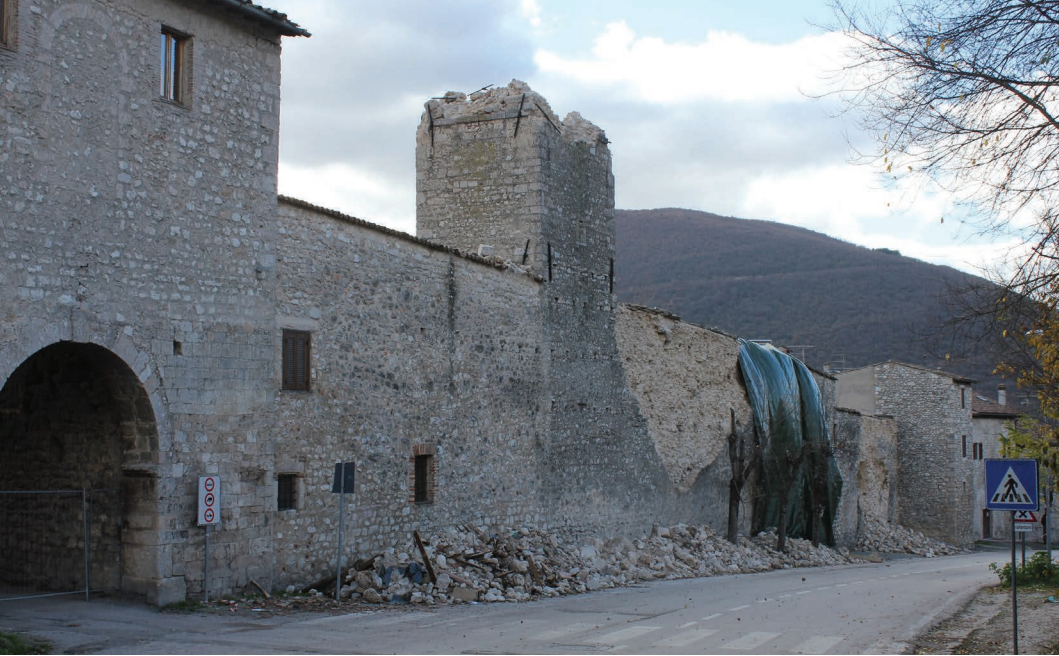
Fig. 06: Norcia, the wall near 'Porta San Giovanni', after the recent earthquake.

The town wall of Norcia has been substantially conserved, although there are clear additions introduced by numerous interventions carried out in the wake of the disastrous earthquakes involving the area at various times over the course of history. (Fig. 06)

The restoration will thus have to be done not only by carefully filling in the gaps, but also by restoring the overall volumetric structure; the fortified town that emerges in the context of the plain of Santa Scolastica constitutes a complex architectural image, consisting of signs inseparable among one another; this palimpsest of age-old stratifications, in which the changing needs of defense and of controlling the territory may be interpreted, meaningfully characterizes the landscape to this day.⁴¹

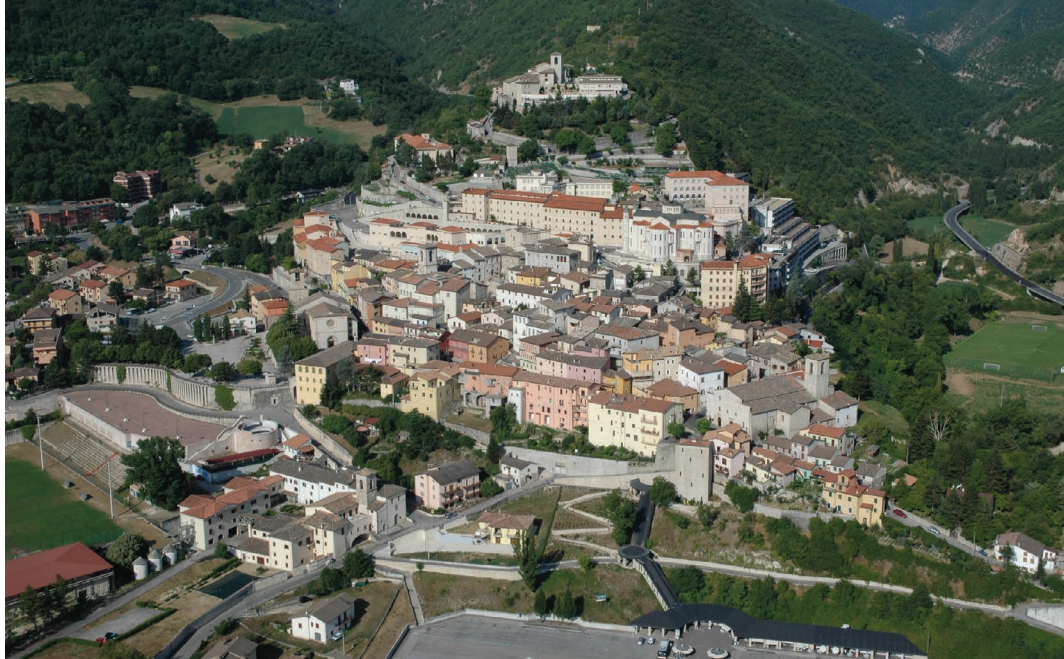
Fig. 07: Cascia, town's view.

On the other hand, the great losses lamented in Cascia's town wall, now a part of their history, have resulted in a gap that, even more than being a 'material' one, signals a gap in memory; in fact, a process of reintegration (or, to put it better, of 're-editing') is not likely to appear, because it would be without sufficient historical and critical grounding. (Fig. 07)
